Manhole Inspection Summary

Manhole # S61O__001MH

Insp Date: **4/30/08 1:03 PM**

Location Address: **1301 S. Ponca St.**

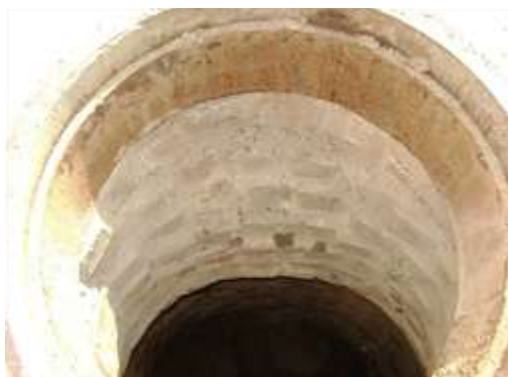
Defect 1

Offset: **8** (in.)

Offset frame

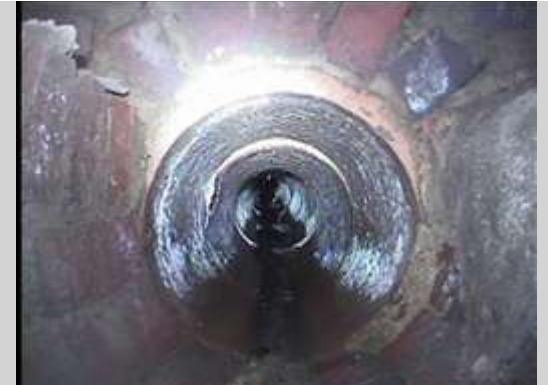
12 O'Clock Outflow

10 in. Circular Gravity Sewer
Pipe Out @ 12 O'Clock

Pipe Height: **9.6** (in.) Rod and Bar (Angled)
Pipe Material: **Clay** ☐ Pipe Lined
Invert Depth: **9.75** (ft.) Flow Characteristics: **Slow**
Deposits: ☒ None ☐ Mud ☐ Sludge ☐ Debris ☐ Grease
Silt Depth: (in.) Deposits Extent:
Infiltration: **None** Pipe Seal Cond: **Sound**

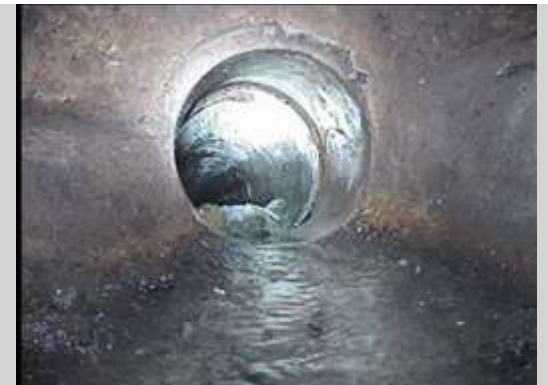
3 O'Clock Inflow

6 in. Circular Gravity Sewer
Pipe In @ 3 O'Clock

Pipe Height: **6** (in.) Rod and Bar (Angled)
Pipe Material: **Clay** ☐ Pipe Lined
Invert Depth: **9.17** (ft.) Flow Characteristics: **Slow**
Deposits: ☒ None ☐ Mud ☐ Sludge ☐ Debris ☐ Grease
Silt Depth: (in.) Deposits Extent:
Infiltration: **None** Pipe Seal Cond: **Sound**

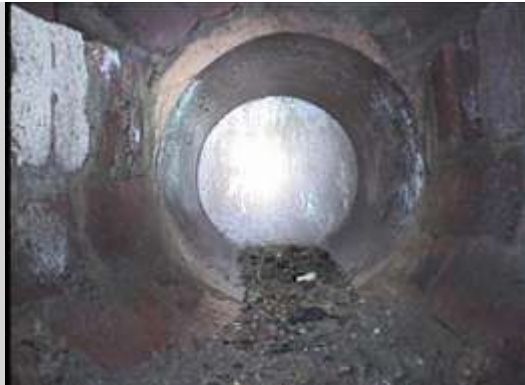
6 O'Clock Inflow

10 in. Circular Gravity Sewer

Pipe In @ 6 O'Clock

Connects To: **Stub connection / abandoned**

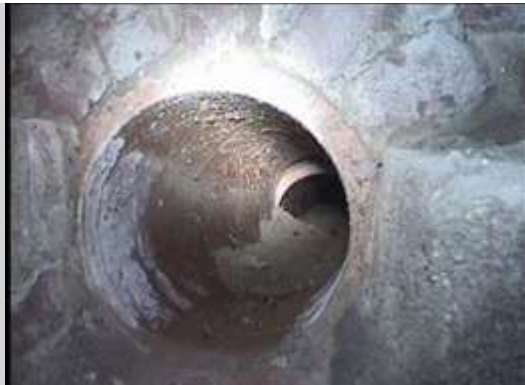
9 O'Clock Inflow

8 in. Circular Gravity Sewer

Pipe In @ 9 O'Clock

Infiltration: **None** Pipe Seal Cond: **Sound**
